SECTION 1 – INTRODUCTION

WINDWARD CAY AT WINDSTAR

Site-Visit Date:
April 20, 2023

Report Date:
April 21, 2023

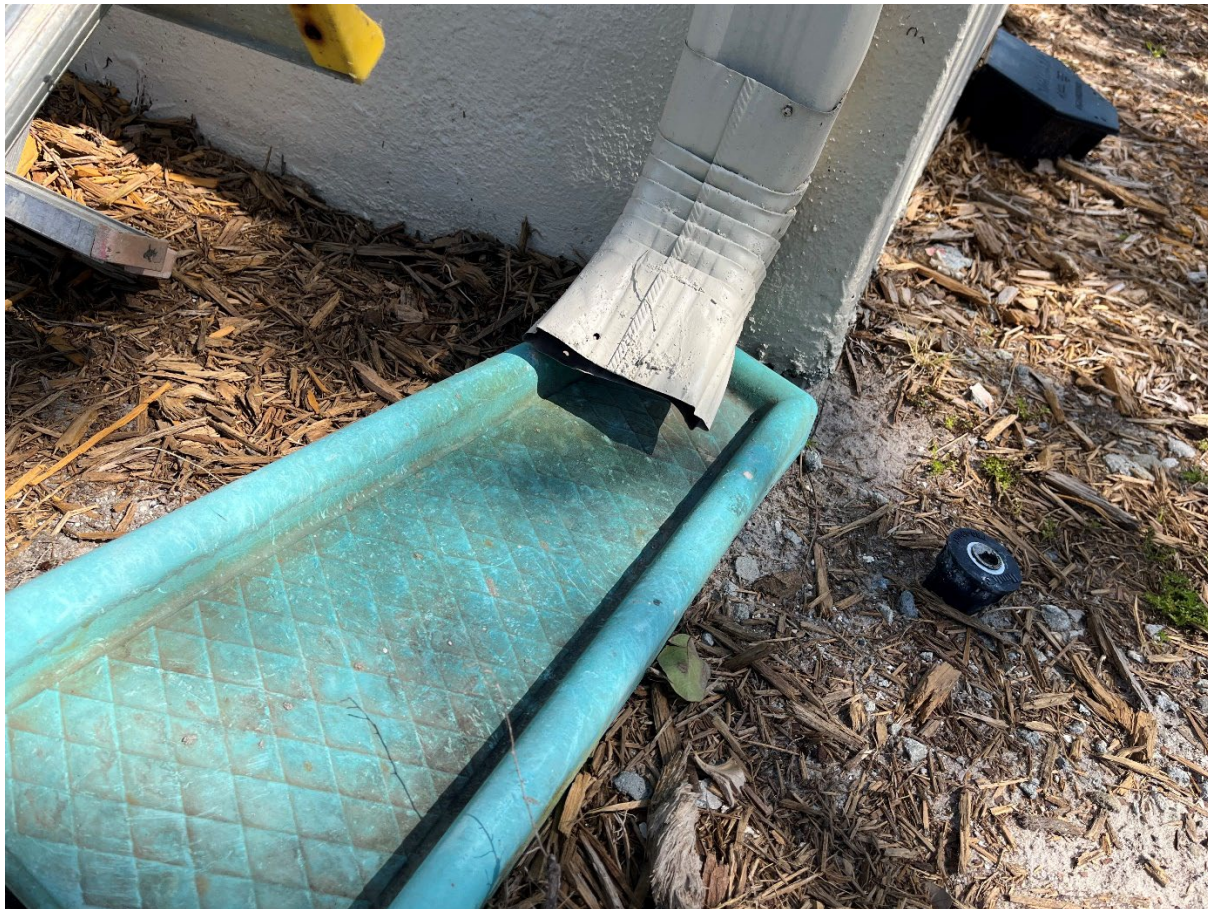
Crushed Ends of Downspouts

A common issue observed on the exterior was damage to the ends of downspouts which will restrict the flow of water draining off the roof. Water backing up in gutters can find its way to the building interiors. Suggest having these repaired as soon as possible.

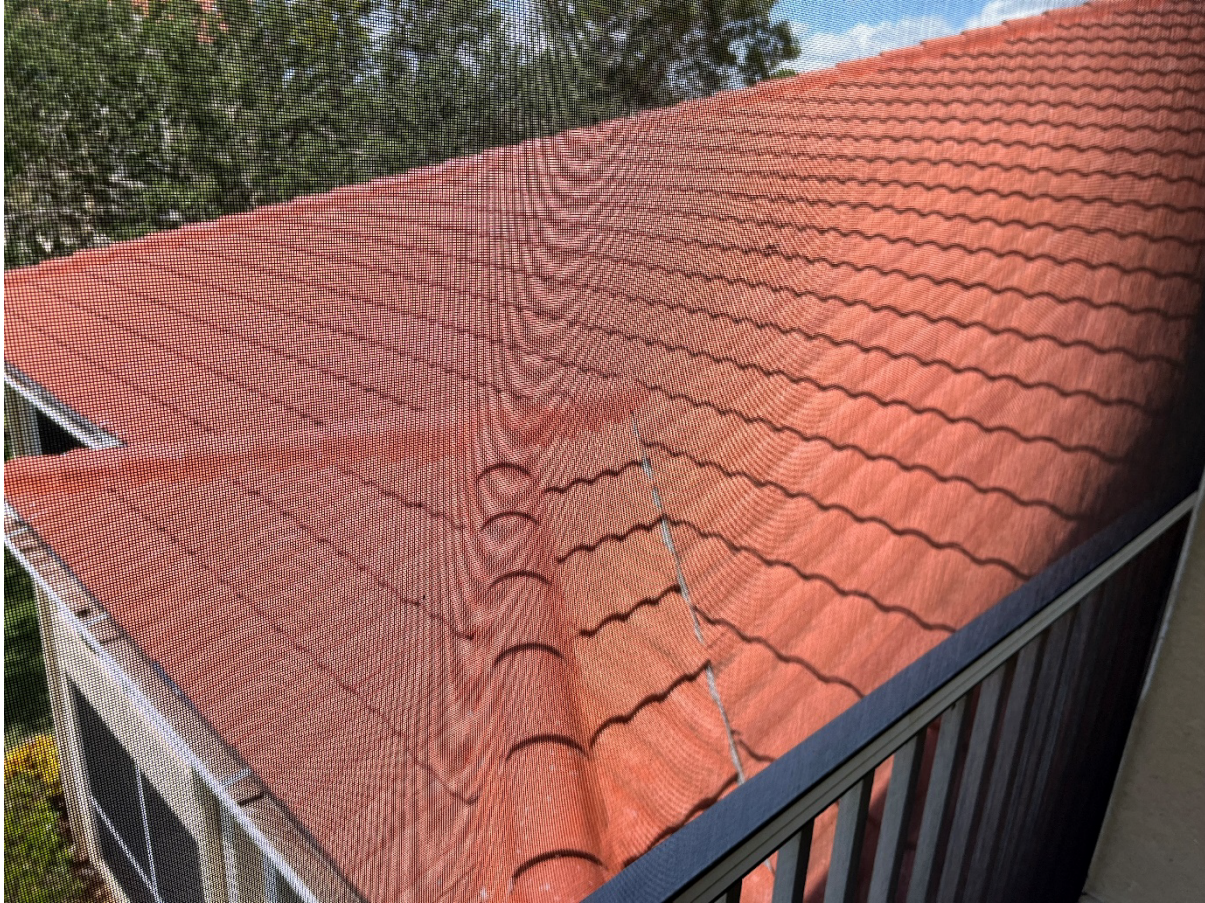
Typical Roof Surface

Roofing consists of colored concrete tiles that simulate terra cotta clay. Tom Engel (past president of HOA board) said that the roofing was only three years old, having been replaced after Hurricane Irma damaged the previous roof. Roofing was in excellent condition but access to the roof was difficult if not impossible, limiting the evaluation of the roof surface.

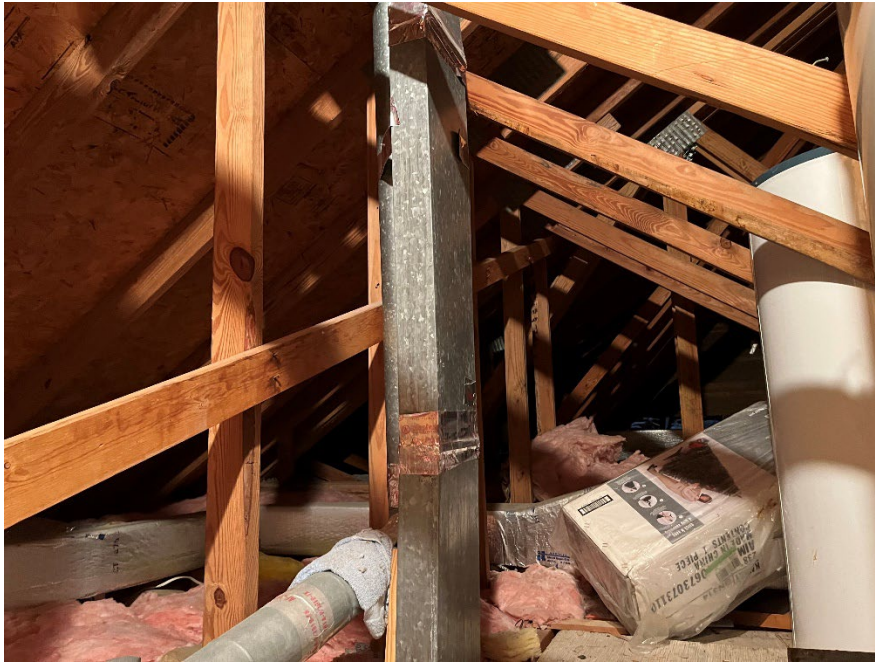
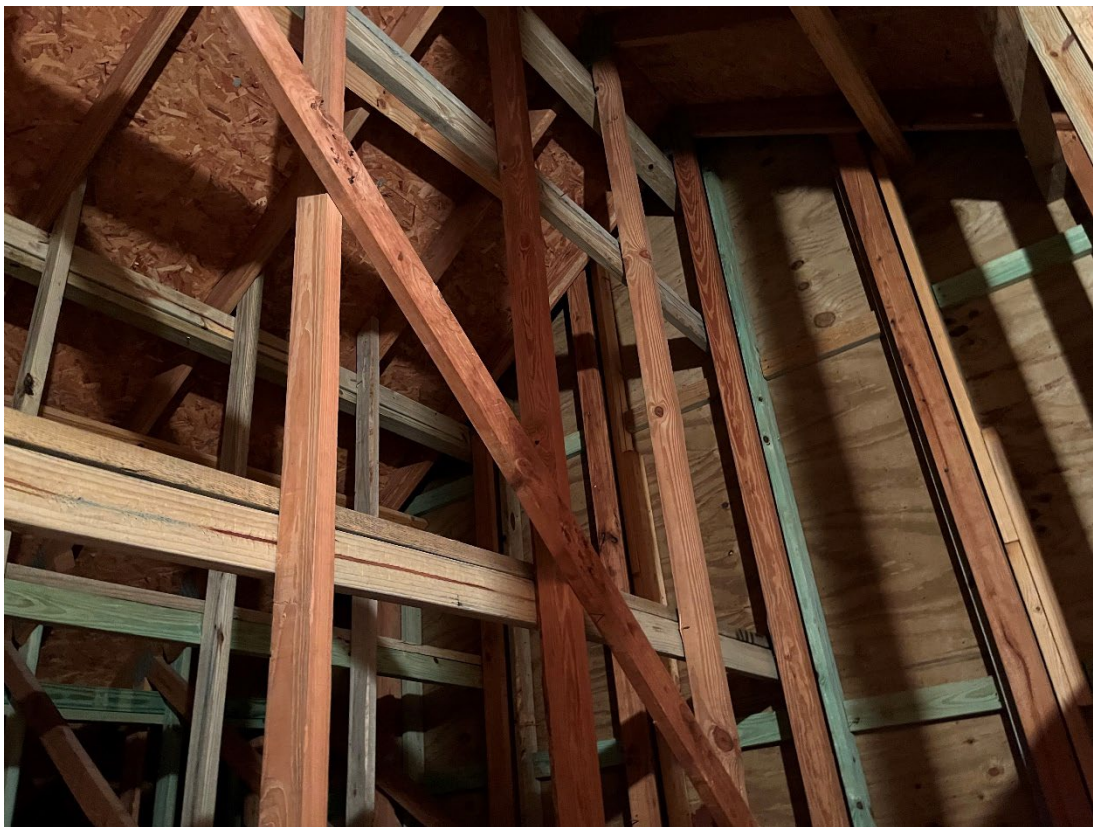
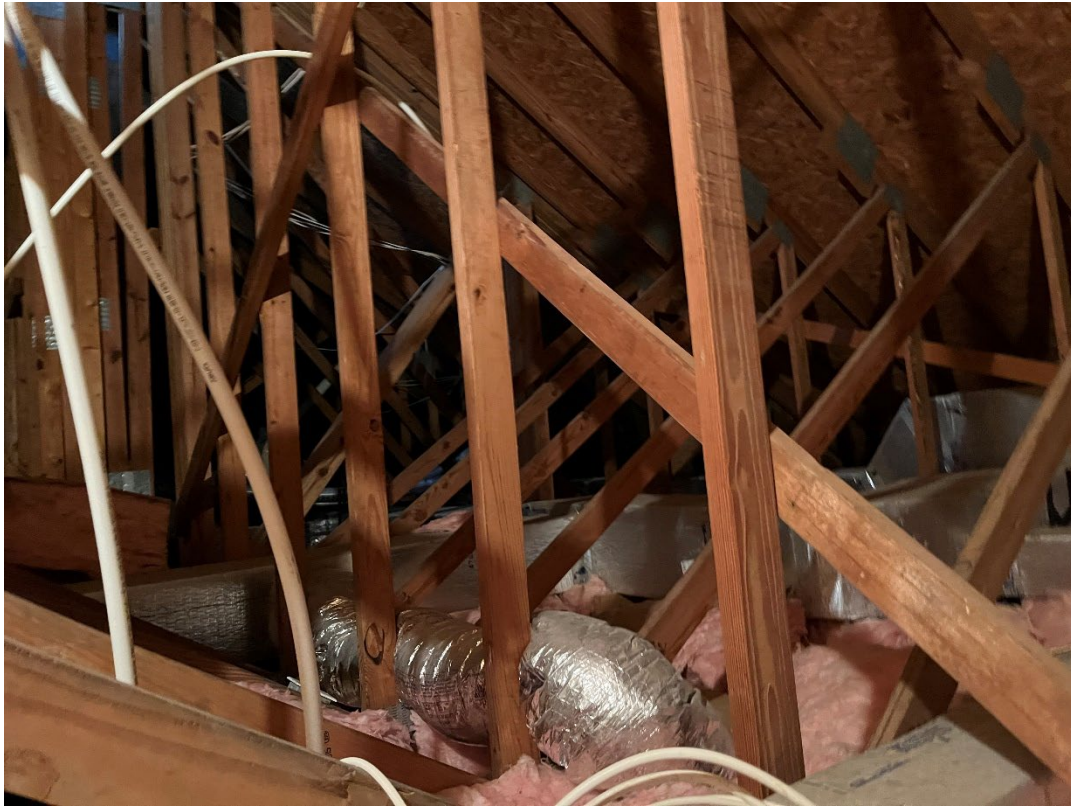
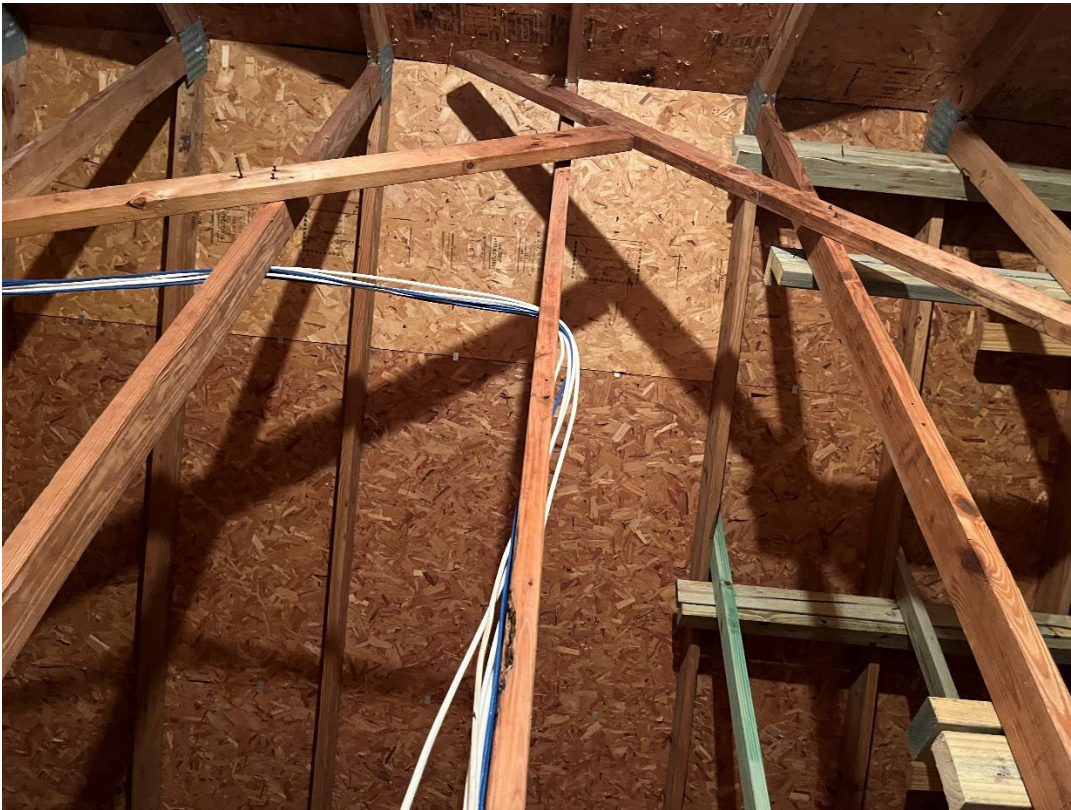
Roof Framing Photos

The roof framing consisted of pre-engineered wood trusses. These were all in good condition and were appropriately size with well-fitting steel gusset plates. Additional cross bracing was added after Hurricane Irma to reinforce the roof framing. This supplemental bracing was well designed and executed. Plywood decking included the required metal hurricane clips and hold down straps were observed in the correct locations.

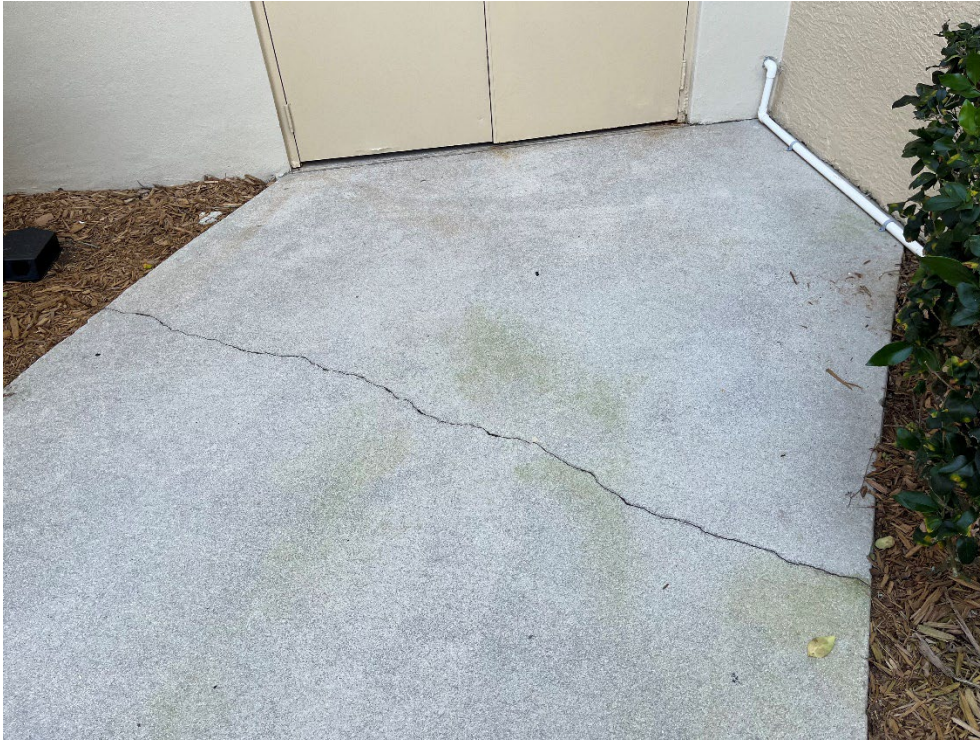
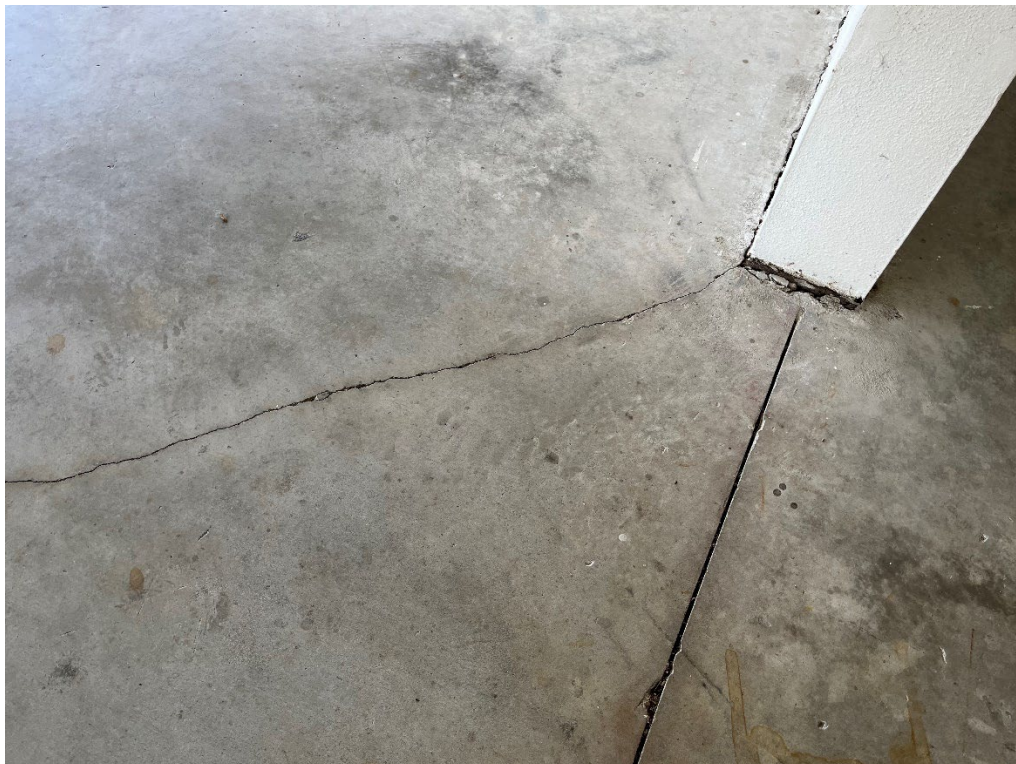
Cracks in Concrete Walks and Slabs on Grade

There were a few cracks observed in the concrete sidewalks close to the building and in the floor slabs on grade of the parking area underneath the building. Water migrating into these cracks can erode the supporting bases and soils and lead to a slab failure in the future. Inspector recommends these cracks be sealed by a reputable concrete contractor who can use high quality materials that will assure that no surface water will be able to penetrate these openings in the concrete.

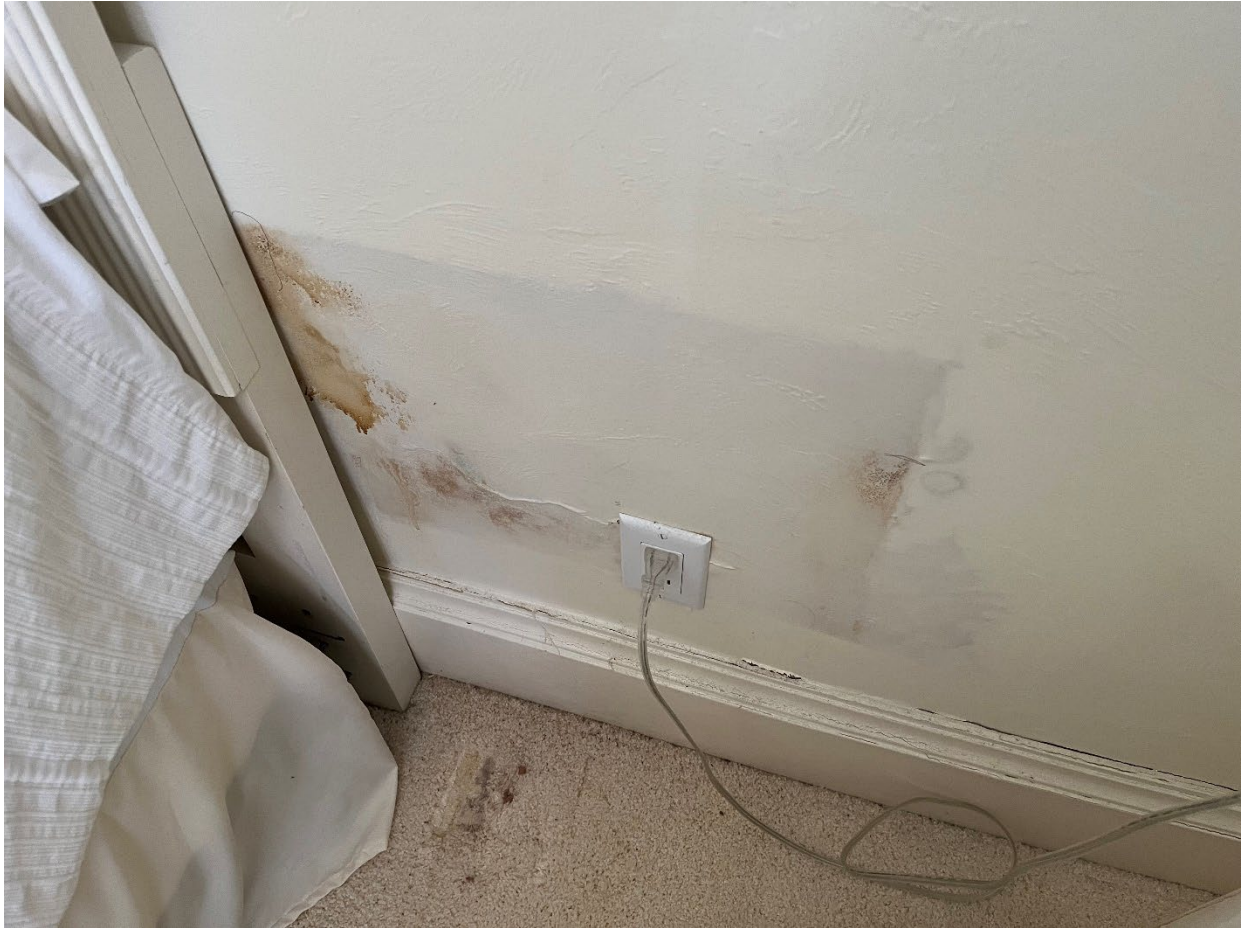
Unit 4608

This unit had a serious active water leak in the Master Bedroom. The leak had stained the wall behind one of the night stands. There was no direct evidence on the exterior what the source of this leak was, but there was a short gutter at the exterior eave above this area that may be overflowing or backing up into the top of the wall. Since the wall construction is concrete with wood furring strips to which drywall is mounted, there is a small cavity behind this wall. Though not a structural issue yet, this kind of water penetration can deteriorate structural components over time. Suggest having a roofing contractor evaluate the eave above this location to determine the source of this leak. Once the leak is repaired, the drywall can be repaired and painted. Area should be monitored for any future evidence of water intrusion to assure the leak has been corrected.

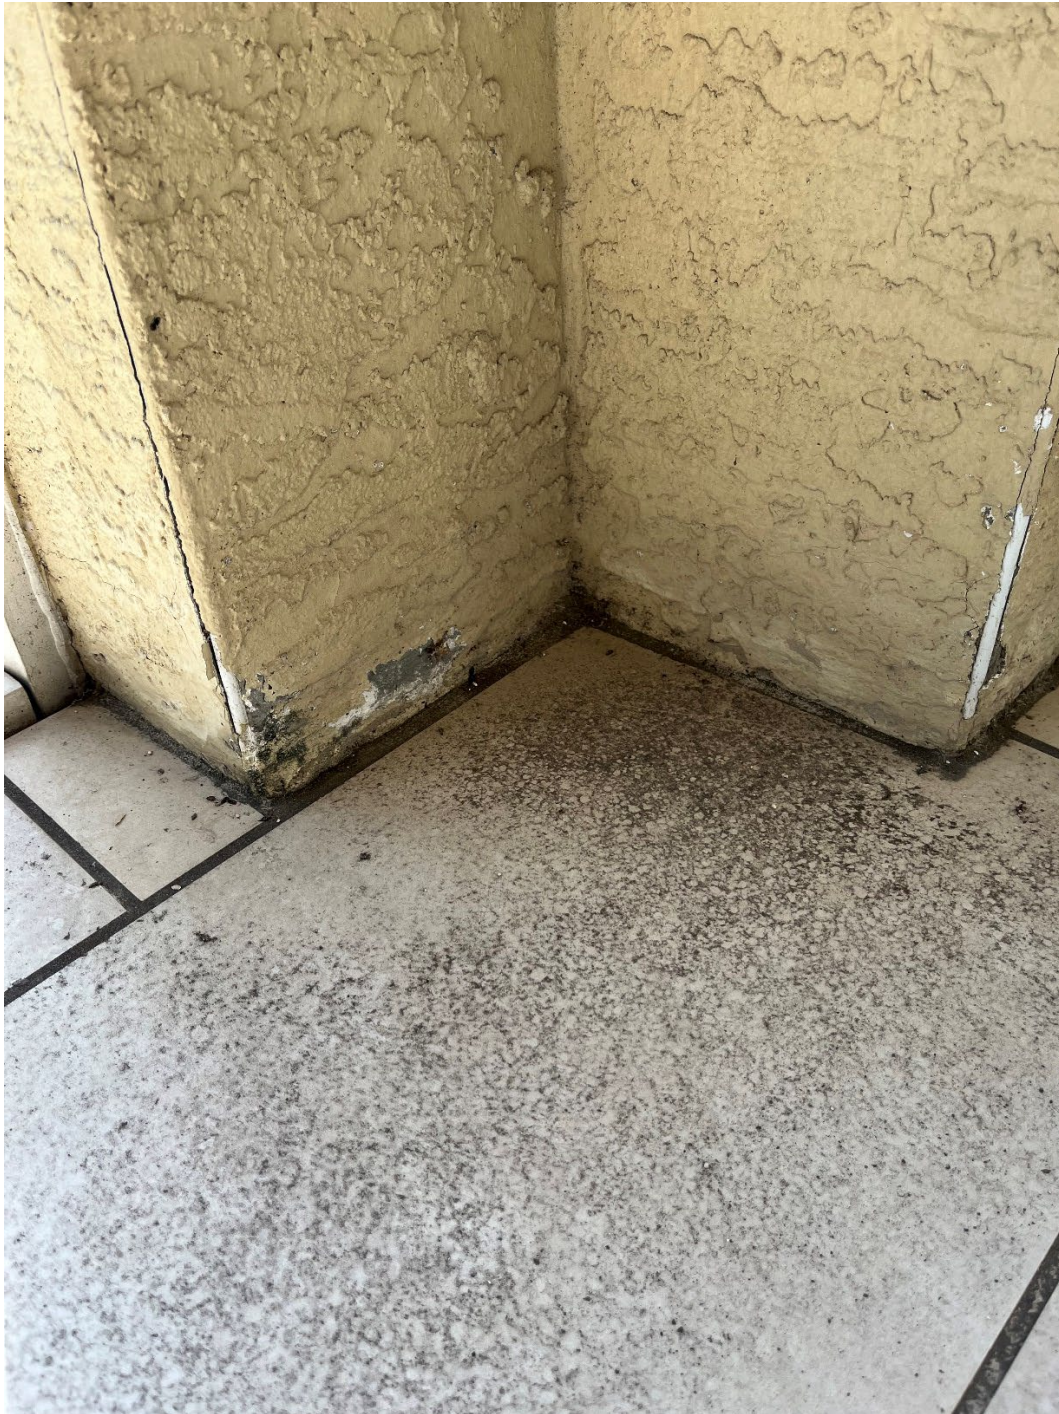
Unit 114 in 4650 Building

This ground floor unit had issues in the stucco of the outside corner of the lanai. Corner beads were cracked and water had damaged the stucco at the bottom of the wall. This is not a structural issue but an ongoing water leak in this area could lead to the deterioration of structural elements over time. Suggest having the stucco repaired in this area then monitor the area to see if any evidence of water damage re-emerges in this location.

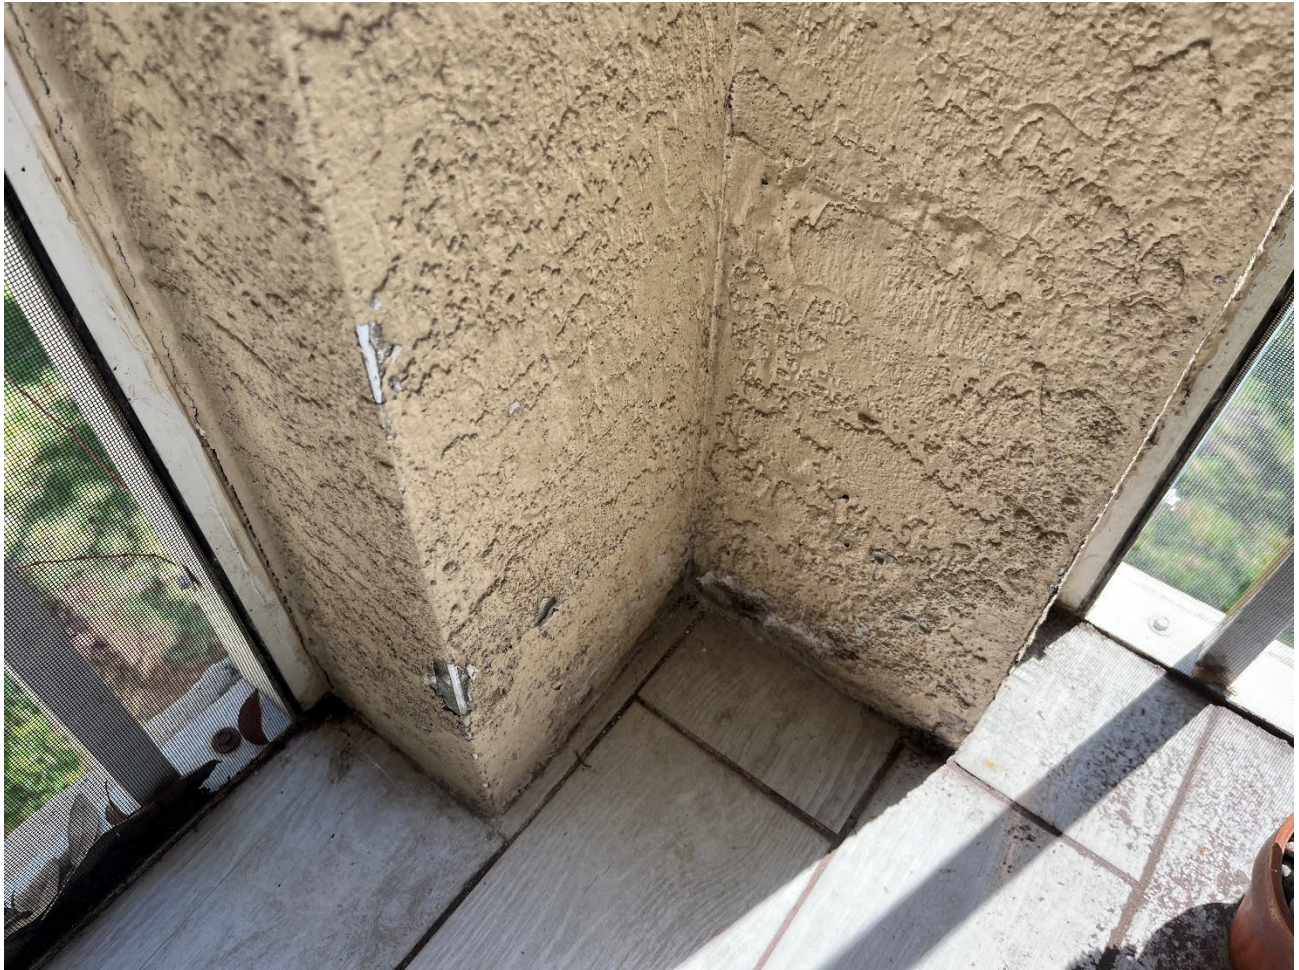
Unit 122 in 4650 Building

This unit had a similar issue to the previous one where the outside corner of the lanai had some corner bead damage where water was allowed to enter behind the stucco. As a result the stucco veneer near the floor was soft and water stained. Suggest having this area of stucco repaired to maintain the water tightness of the veneer. Since this seems to be a common occurrence in this building; suggest having all outside corners at the lanais at each floor evaluated for the need of stucco repair. Behind this stucco are critical load bearing wall elements the need to be protected from water damage.

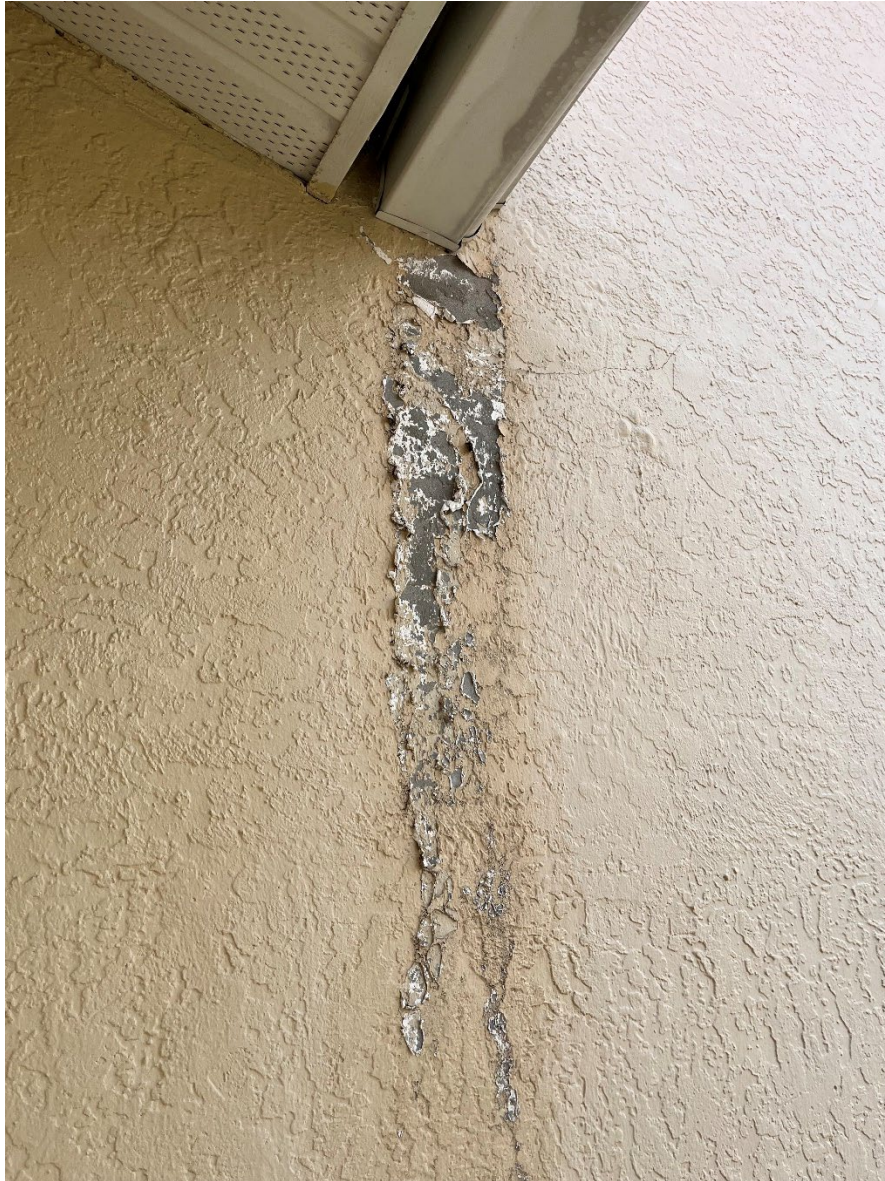
Eave of 4650 Building

This gutter is located on the front left side of the 4650 Building. This gutter is sloping the wrong direction away from the downspout rather than toward it as required. Because this issue has not been addressed for a significant amount of time, water damage to the paint and stucco finishes has occurred. Suggest having a qualified roofing/gutter contractor adjust this gutter to make it slope in the correct direction. There may be a possibility that the gutter at this location is too small to handle the run-off from the roof in this location. Contractor can determine if a larger gutter here would rectify this issue.

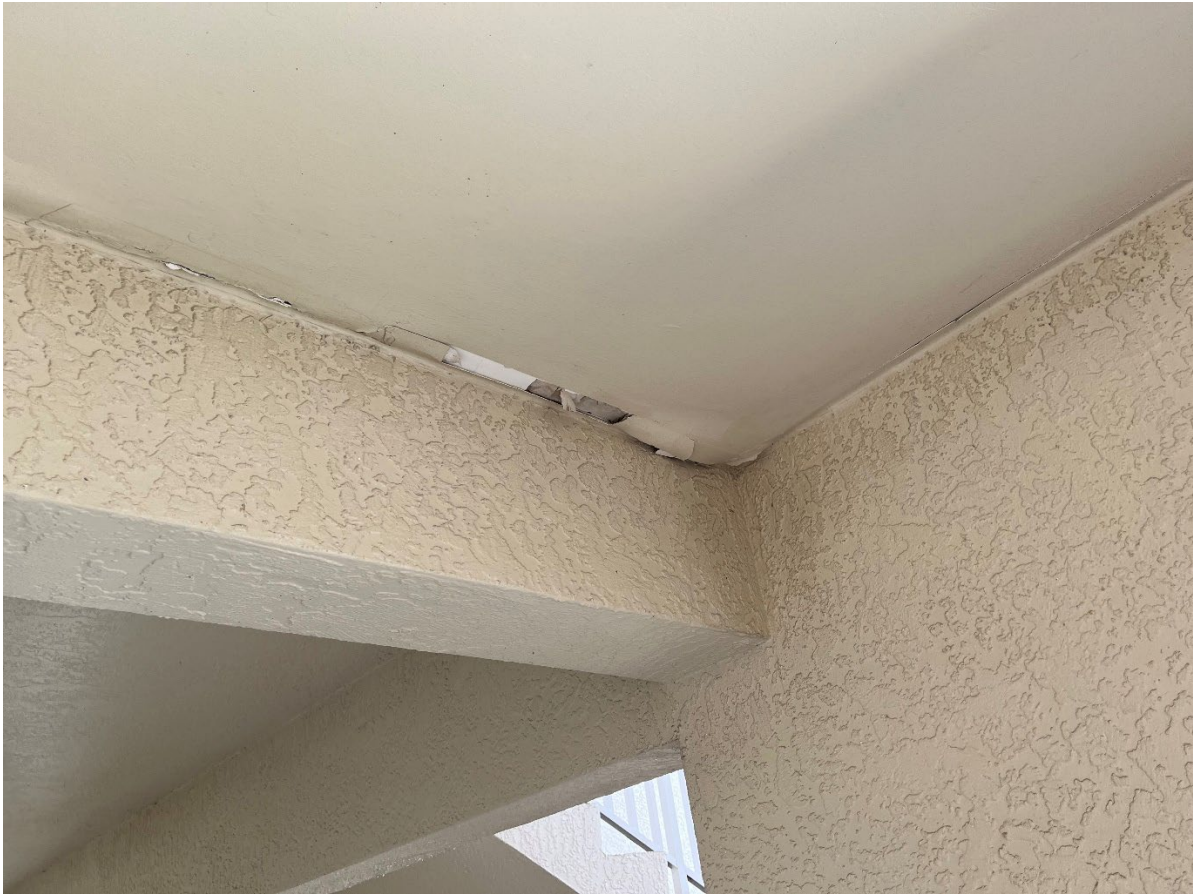
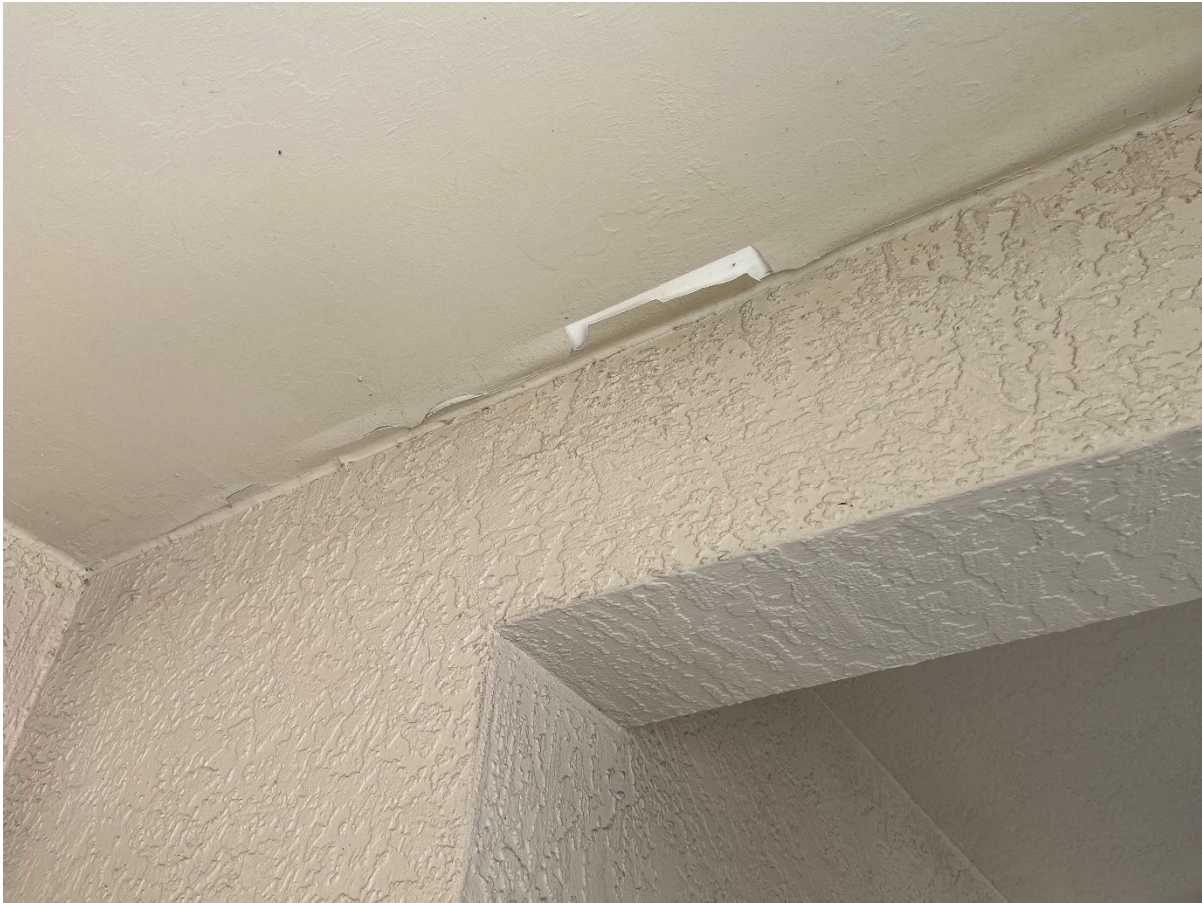
Inspector also noted there is water damage to the ceiling underneath the walkway in this area as well, and this water overflow seems to be the logical source of this damage. The following two pictures are of the underside ceiling of the walkway. Once gutter issue is resolved, have this ceiling repaired and monitored to assure the source of the water leak causing this has been adequately addressed.
