SECTION 1 – INTRODUCTION

WINDWARD CAY AT WINDSTAR

Site-Visit Date:
April 20, 2023

Report Date:
April 21, 2023

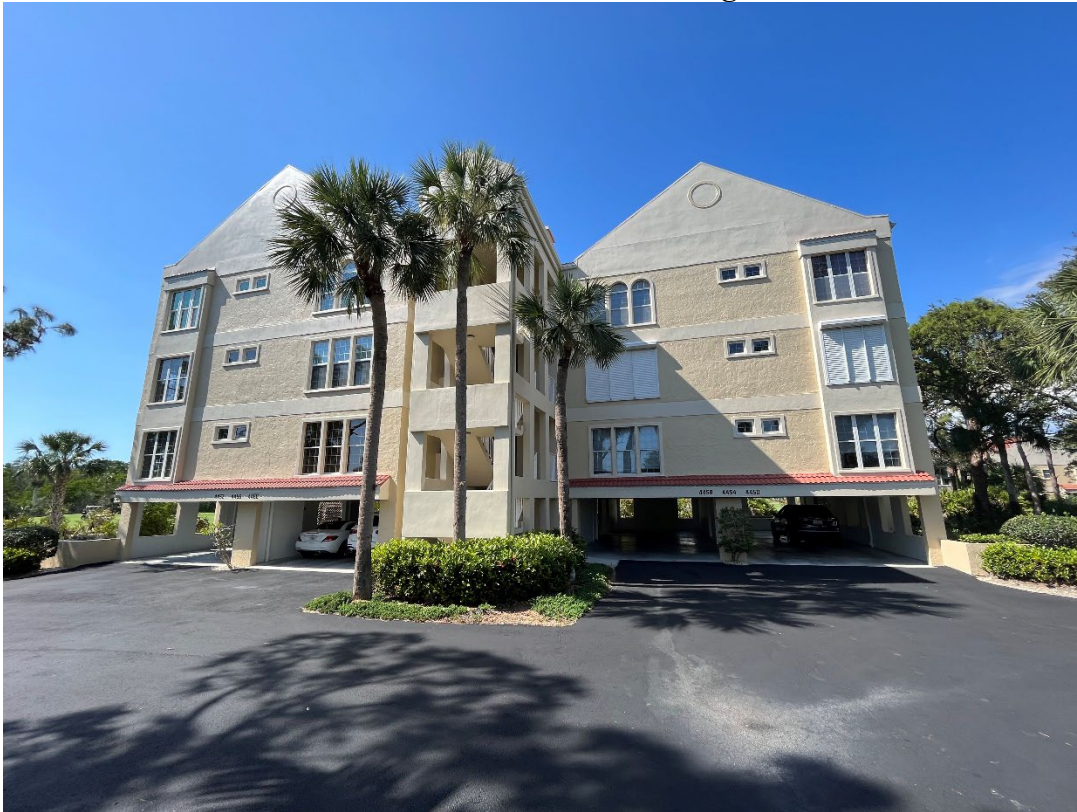
Front View of 4450 Building

The exteriors of these facilities did not exhibit any visual signs of structural deficiencies or impending failure. Each face was examined closely for any abnormalities or visual indications that more than this Phase One visual inspection is necessary. It is the opinion of this inspector that no visual signs or indicators are present currently, so no further investigations are warranted at this time. There were a few exterior issues that warrant mentioning in this report:
